Preserving cultural heritage by preventing bacterial decay of wood in foundation piles and archaeological sites

Final report

EVK4-CT-2001-00043

Bacpoles

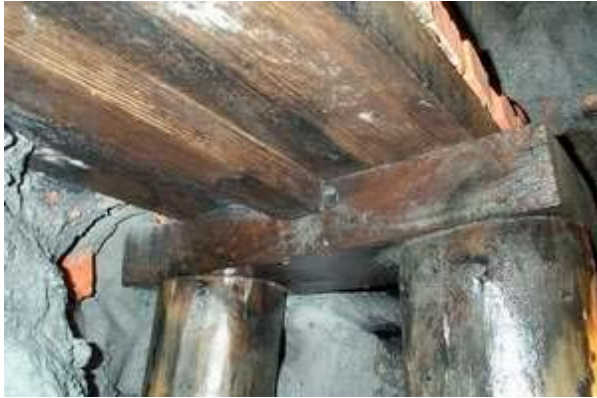
Figure 7: Amsterdam foundation

In other parts of the Netherlands variations of above are found, depending on the thickness of the soft layers. There are two main types of wooden foundations in the Netherlands. They are known as an “Amsterdamse fundering”, used in and around Amsterdam and a “Rotterdamse fundering”, used in and around Rotterdam. An Amsterdam foundation is a foundation with cross beams and pair of piles (see figure 7). A Rotterdam foundation is a system of stand-alone piles and only longitudinal beams (see figure 8).

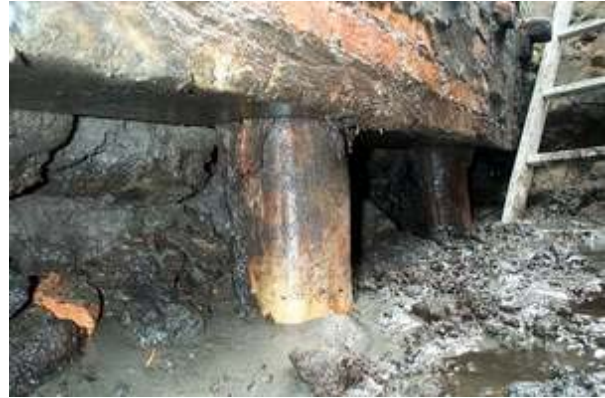
Figure 8: Rotterdam foundation

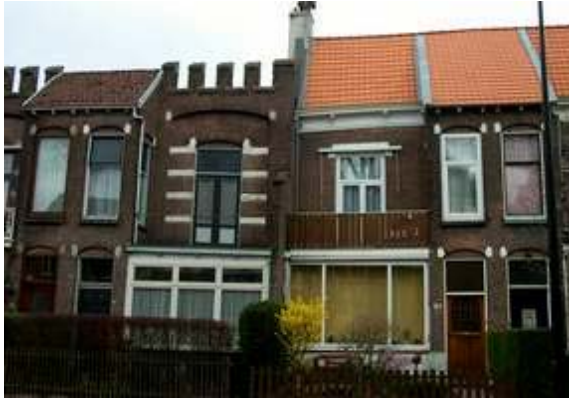
Figure 11.

In many cities, buildings with foundation problems are located in the quarters built from 1875 up to 1940. Most times foundation problems are recognised by the settlement behaviour of the buildings, which is illustrated in figures 11 and 12.

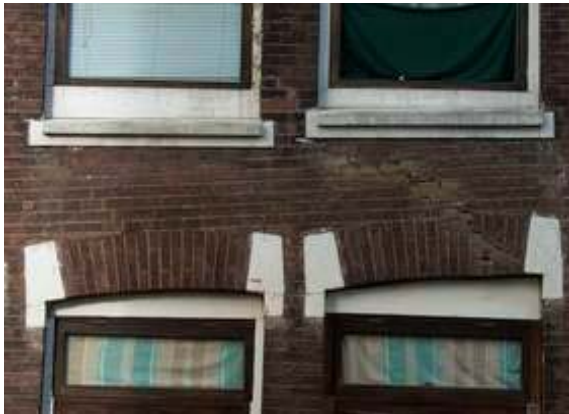
Figure 12b

The house of figure 12a has a differential settlement between right and left wall of more than 20 centimetres. This causes such a high distortion that cracks in the brickwork occur, causing structural damage to the house (see figure 12b).

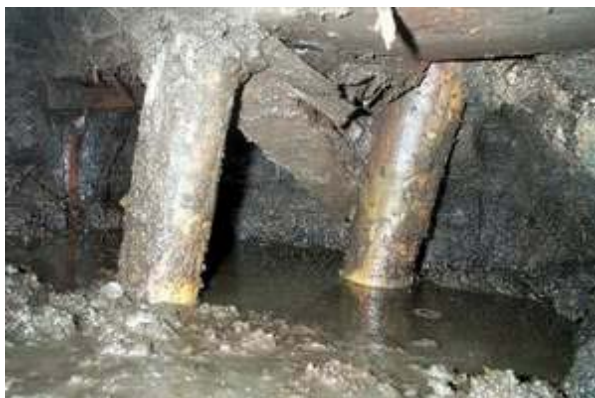
Figure 13: softrot.

Decay of piles due to softrot (groundwater table below top of piles; see figure 13) and/or bacterial degradation (see figure 14).

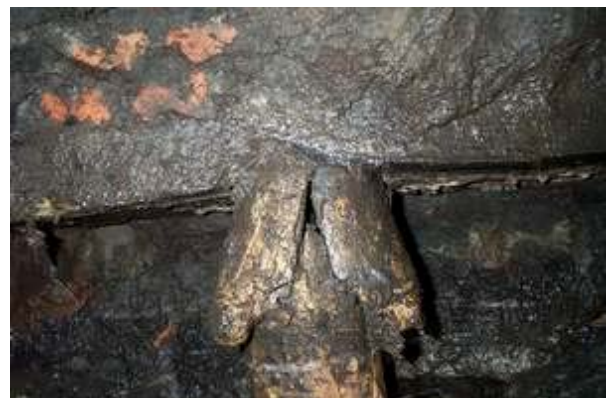
Figure 14: bacterial degradation

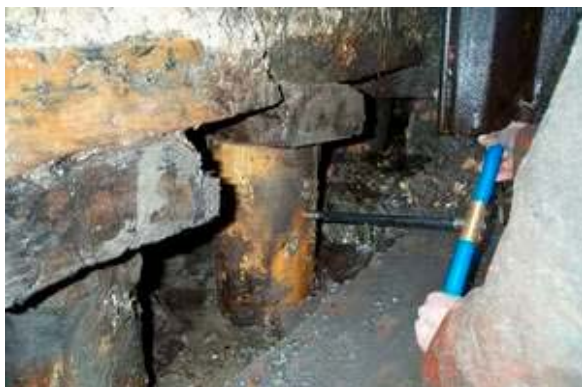
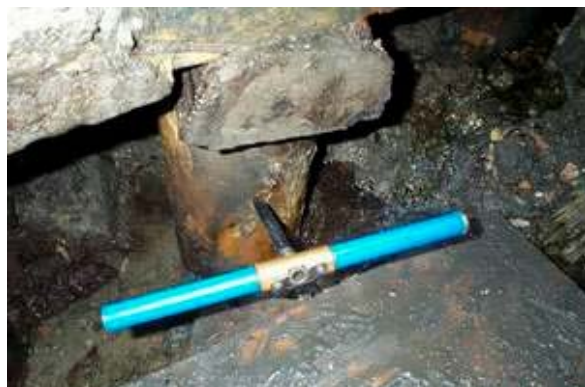
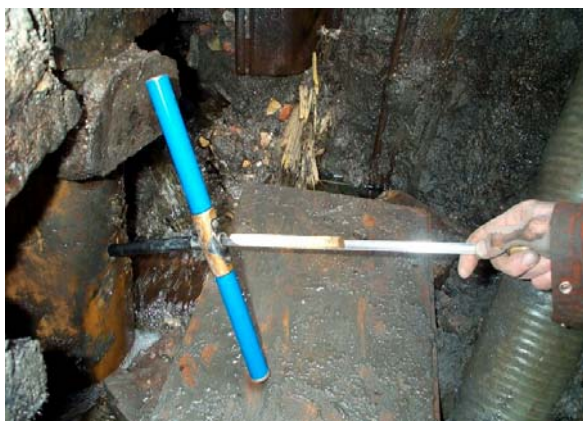
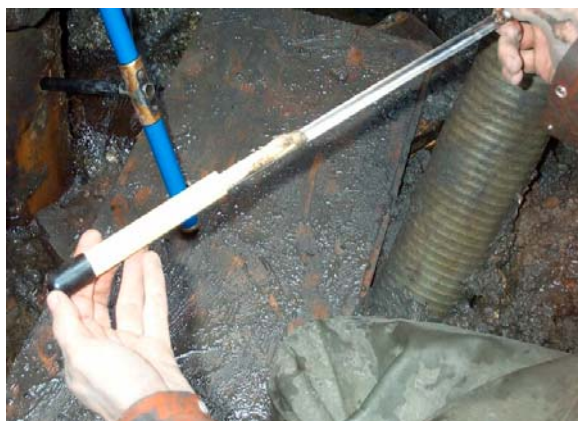
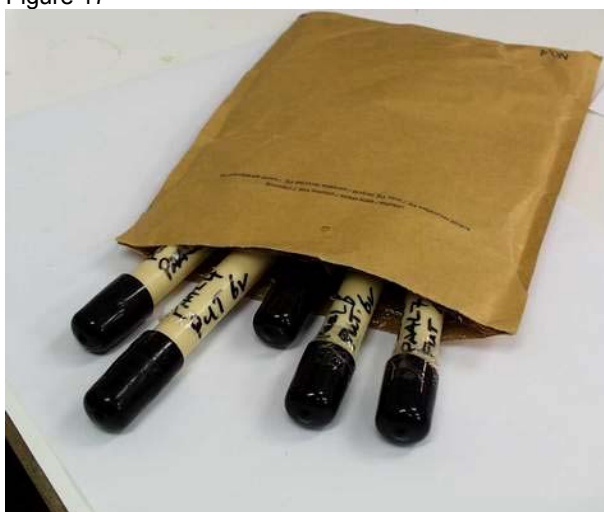
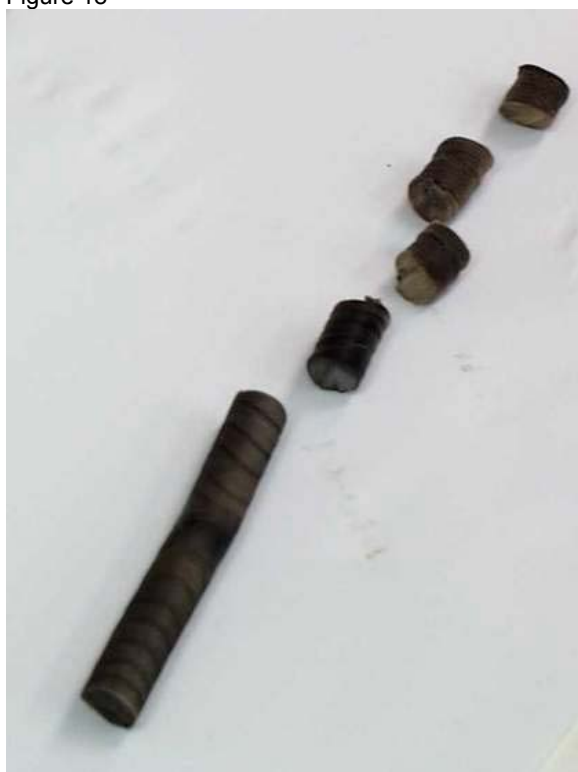
Fig 15 – 20: showing the sampling strategy with an increment borer, post in a sealed plastic tubes and investigated in segments of 15 mm.

According to the protocol the sampling is done by using an increment borer with a inside diameter of 10 mm. From each pile a core is taken from the bark to the pith approximately 500 mm below the pile head. Immediately after boring the core is put with some water in a plastic tube (see figure 15 to 18), sealed on both sides and send by post to the laboratory. In the laboratory the core is split into sub-samples of 15 mm (figure 20). For each core the species and the type and degree of degradation is determined by microscopic analysis. The moisture content and the wood density is determined by weighting and drying for every sub-sample. After having investigated a huge number of whole pile disks (figure 21) it was possible to study the relationship between wood density and moisture content and the compression strength of a pile in more detail. A simple model is calculated to estimate compression strength from the quotient of wood density and moisture content. Figure 22 shows this relationship for 100-year old Pine piles with 93% regression fit.

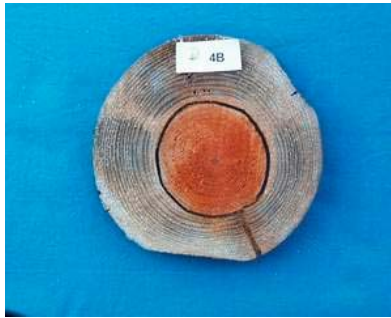
Figure 21: Pile head used for estimation of compression strength; heartwood stained red.

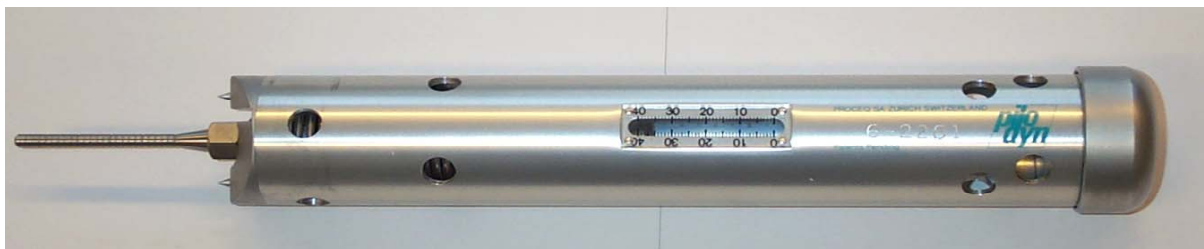
Figure 23: Pilodyn wood test hammer

Before use, the pen of the hammer is pushed inside. When a button is pushed in the pen comes out and penetrates the wood with a uniform force and the penetration depth is determined. At least 3 measurements are carried out at each pile (spread over the circumference of the pile) at approx. 150 mm below the pile head. The average penetration depth is an indication of the degree of the decay.

In the foundation pith the quality of the piles are determined by using a Penetrometer or wood test hammer. Figure 23 shows a Pilodyn wood test hammer (comparable with a concrete or Schmidt Hammer).

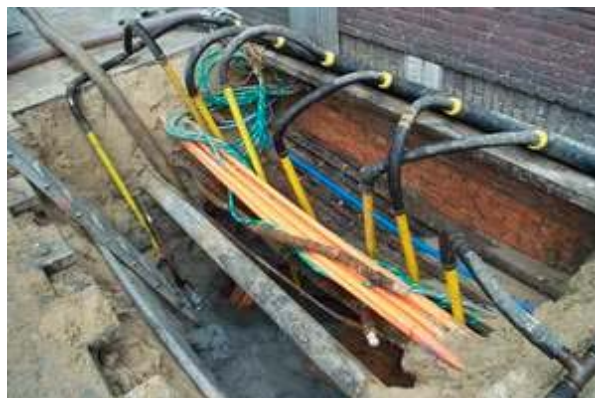
Figure 27

Two examples are given how inspections are carried out in the Netherlands. The first example is about a sound foundation and the second is about a foundation with degradation. Figures 26 and 27 give an impression for the first location where the pit has been excavated. In figure 27 it is seen that it is not always easy to excavate close to the building. A dewatering system was necessary to lower the groundwater table.

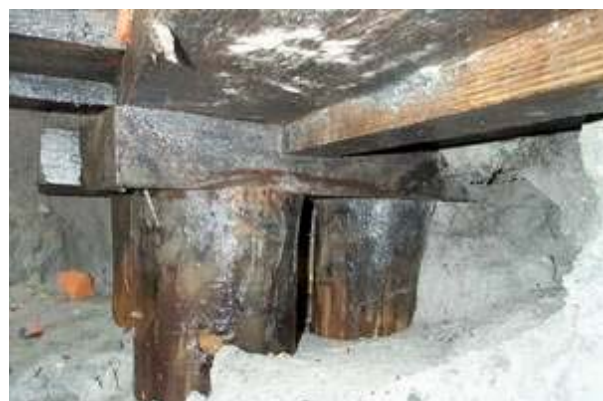
Figure 28

After 90 years the foundation construction is still in perfect condition (see figure 28 and 29).

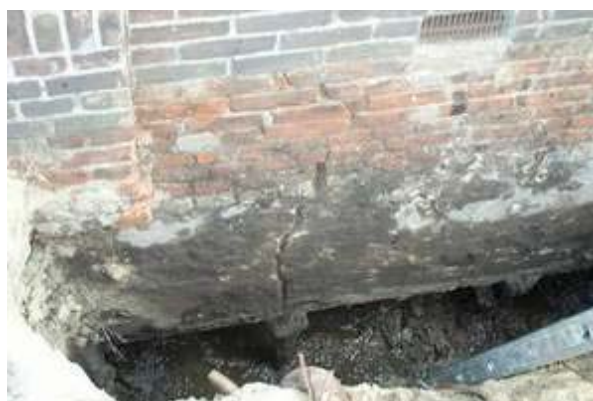
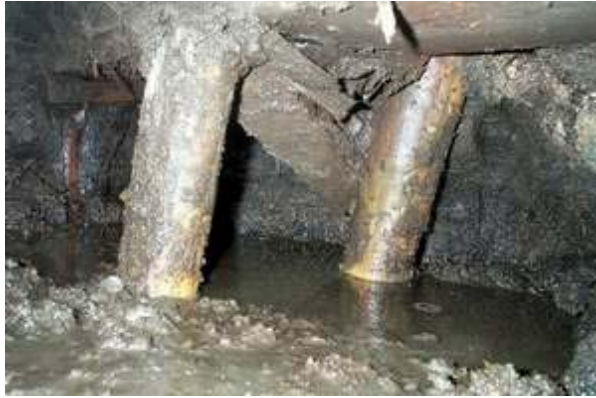
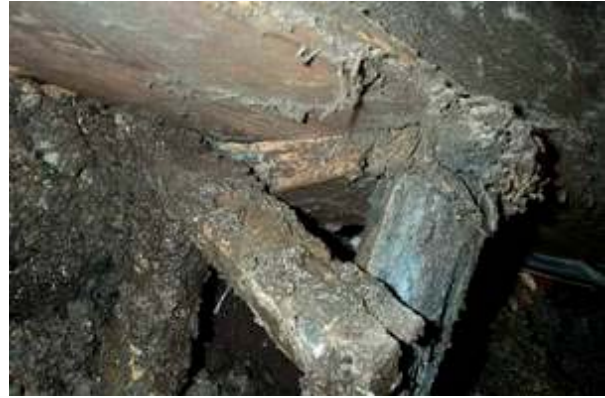
The figure 31 – 36 gives an impression of the second example of an inspection with a poor foundation. Due to a groundwater table, which is below the level of the wooden structures, softrot in combination with bacterial degradation of the wood, caused a terrible condition of the crossbeams and the top of the piles. In such a case foundation replacement is the only option to preserve these houses.

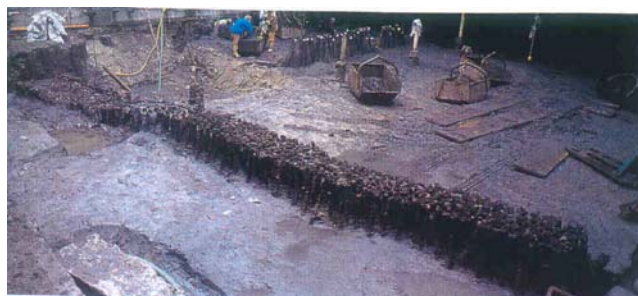
Figure 53a: The oldest foundation piles found recently within the basement of the building of the ex-cinema *San Marco*.

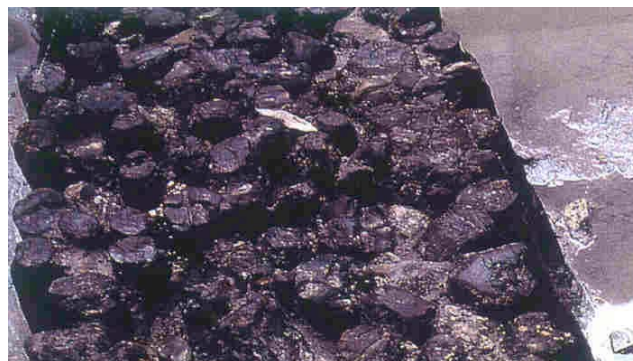
Figure 53b: The row of piles is made of small logs 8 to 16 cm width.

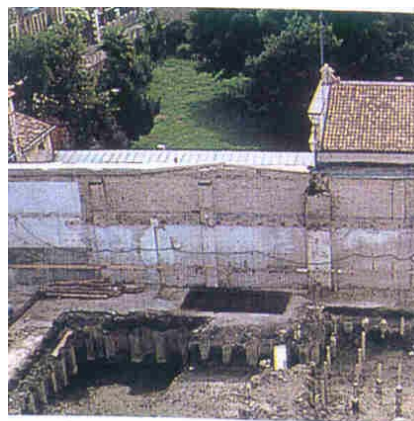
Figure 56b:
The excavations within the archaeological site of *S. Alvise*, with the foundations dating 13th – 14th century.

The excavations undertaken recently near *Sant'Alvise* in *Cannaregio*, on the northern margin of Venice (Fig. 56), has shown how the settled area was enlarged using a sequence of embankments made of oak piles connected horizontally, at the intertidal level of the lagoon, by planks fixed with wooden nails. The ground was then filled with mud dug from the surrounding canals, together with old building material and other types of debris. In another interesting finding, on the *Giudecca* island, an old *fondamenta* (a pathway located at the margin of water, buildings or squares) built between AD 1300 – 1500., was recovered after a casual excavation. The oldest part of the wall is made of a small type of bricks, the latest of Istria stones. The foundations beneath are made of piles of black poplar (*Populus nigra*) and of European white birch (*Betula alba ssp. pendula*), while the large planks over the piles are made of oak and larch.

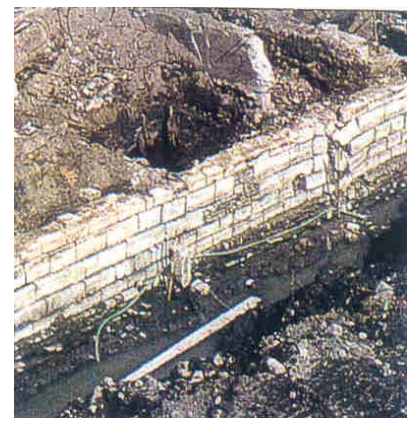
Figure 56c:
The long wall of Istrian stones, with its foundation piles beneath, dating 16th century, found on the island of *Giudecca*.

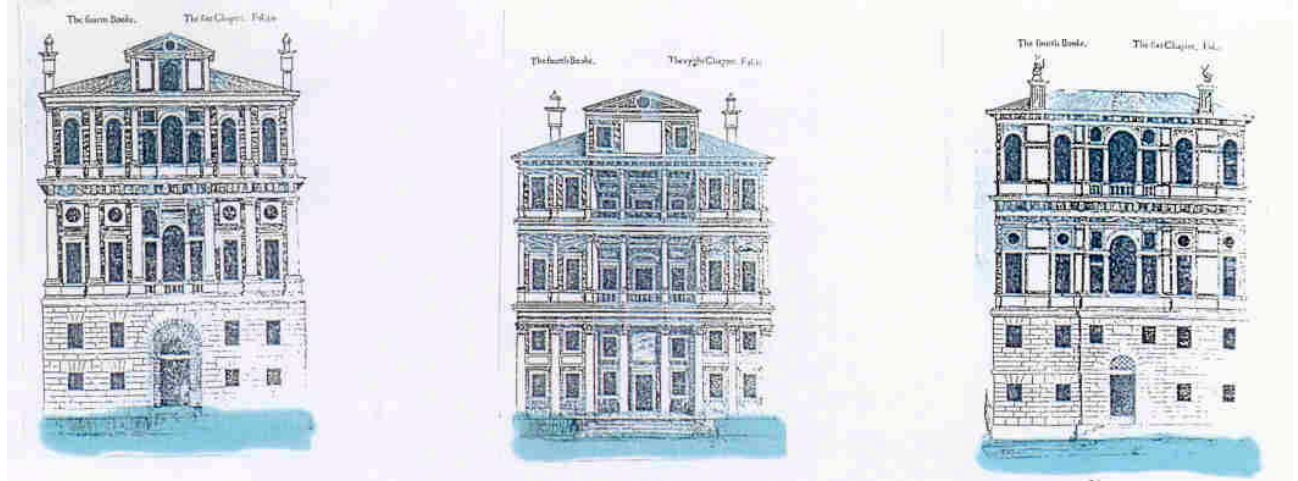
Figure 57a. Examples of the main facade of a city palaces facing the *Canal Grande* in Venice.

Considerably changes in the way Venice was built are related to time, to the different loading capacity of the ground and to the importance of the buildings. (Fig. 57a and 57b)

The typical structure of a palace facing a larger canal in Venice is that represented in fig.57. The pile foundations interest only the main structural walls. The piles were driven into the soil by a handy system or more recently by a machine like that represented in fig. 58.

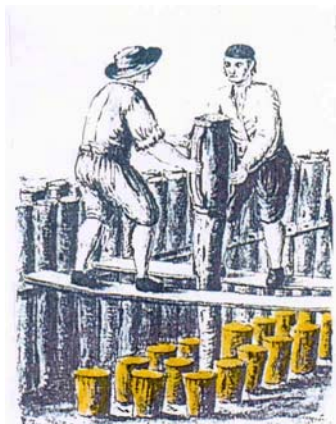
Figure 58a.
A system for driving wooden poles by hands.

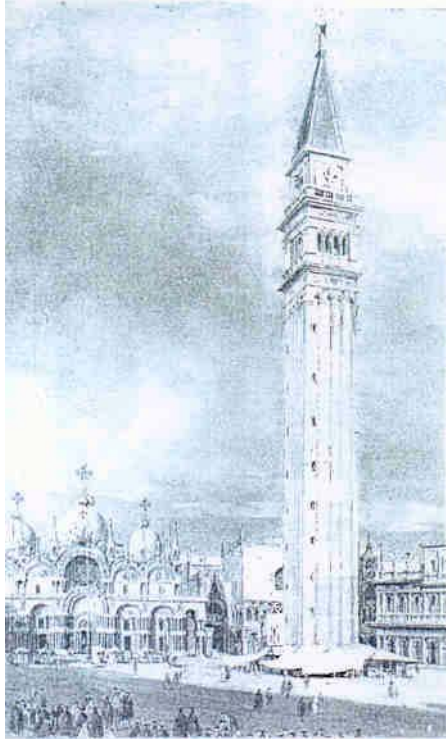
Figure 63a

The tower of S. Marco, that collapsed in 1902, had a foundation made of many courses of Istrian stones and a Zattaron made of two thick layers of plank lying on a few rows of wooden piles.

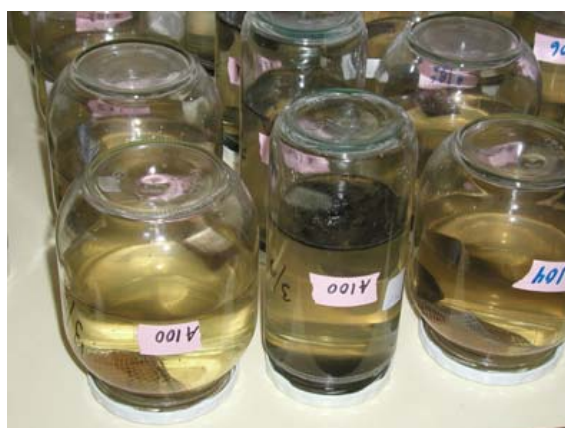
Fig. 1. Original BACPOLES samples incubated in inverted jars with sterilised media, kapok and small pine samples.

The procedure was basically to take a small wood block (approx. 1 cubic centimetre) from the wood. This was done with sterilised tools. Each sample was transferred to a flask or jar with mineral salts medium plus fresh pine wood and ca 20 mg of kapok (Fig. 1). The flasks/jars were sterilised in an autoclave. Incubation occurred at ambient room temperature (22°-24°C). The cultures were checked for erosion bacteria attack on the wood or kapok fibres at irregular intervals during a period of up to 32 months. Prior to examination, one wood block or a few kapok fibres were removed from the jar under sterilised conditions. Thin sections were cut by hand with a razor blade from the wood block and stained in order to highlight the microbial attack. Kapok fibres were stained directly without processing. Both fibres were examined carefully for microbial attack on the cell wall by erosion bacteria, using light-microscopy (Fig. 2,3). The first step in the attack was attachment by the bacteria to the available surfaces of the substrate, followed by erosion of the surface. The bacteria always seemed to align themselves along the cellulose microfibrils. Thus, bacteria degrading the outer part of kapok fibres were oriented transversely to the fibre axis, whereas bacteria in the lumen were oriented along the fibre axis. Microscopy suggested that the bacteria moved over the substrate by gliding.

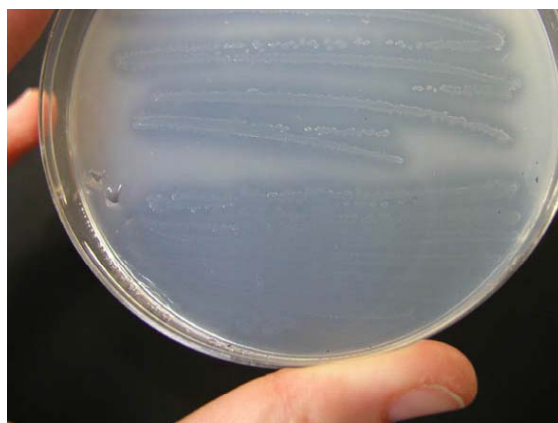
Fig. 9. Cellulolytic bacteria cause clearing zones on cellulose agar. These bacteria are not able to degrade wood, but are present in the microbial community surrounding erosion bacteria.

A large number of bacteria were also isolated on various agar media. Some were isolated on cellulose agar media where they caused clearing zones suggesting cellulolytic activity (Fig.9). A number (ca 16) of pure strains were sent to UoP for identification. Most of the bacteria isolated were also tested for degradation of wood and kapok fibres, but all pure strains of bacteria tested failed to show any signs of degradation.

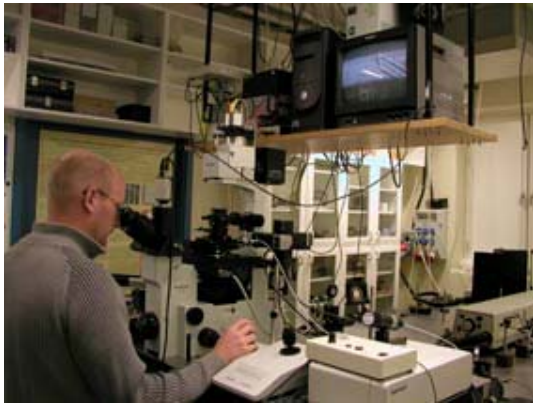
Fig. 10. Advanced optical tweezer system in work at Dept. of Physics, University of Umeå.

1. By use of the optical-tweezer-technique single bacteria with morphological similarities to erosion bacteria were selected from a macerated fibre droplet one by one with help of a micro-injection-needle (Figs. 10,11). The method was time consuming but very successful. Each vial for molecular analysis contained between 4 and 20 single bacteria.

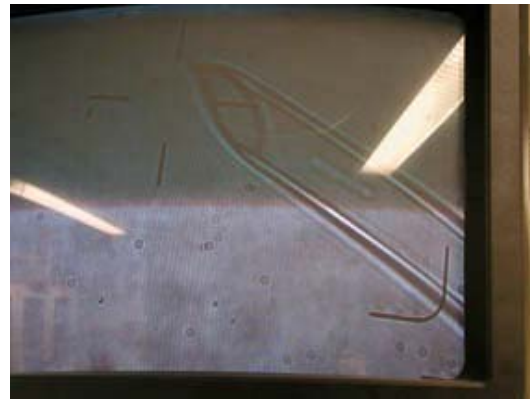
Fig. 11. The process of trapping single bacteria and their way into the microinjection needle could be followed on the monitor.

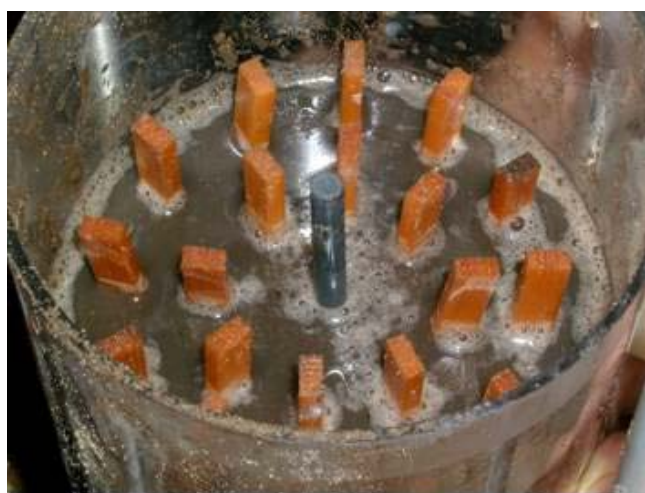
Figure 2. Distribution of the samples of one layer in the Microcosm. (At this stage in the middle of the MC is a plastic stick to keep the space for the attacked wood, added later)

In each MC 2 samples of the inner and 2 of the outer circle in both layers were investigated using light microscopy. Each wood sample was examined at 3 heights (top, middle and bottom) with transverse and tangential sections.

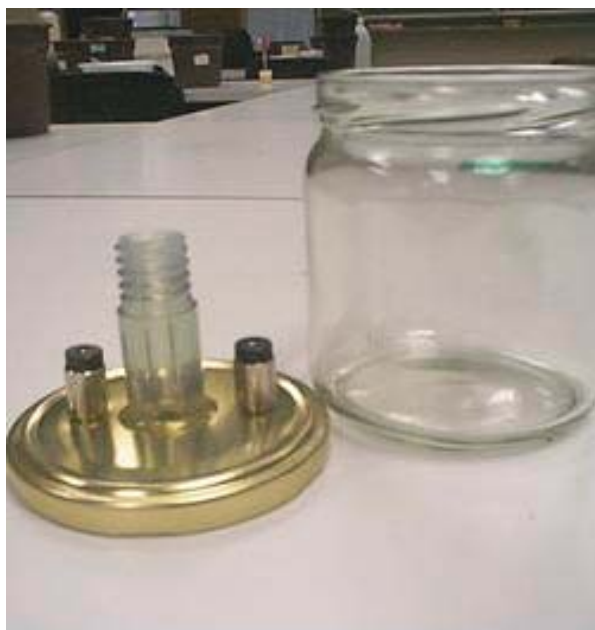
Figure 14. Glass jar and twist off lid equipped with in and out flow valve and septum closed cylinder for water addition

Glass jars of 500 ml volume with modified twist off lids were used in the second microcosm experiment (figure 14). The microcosms (MC) were connected to an automated GC-ECD and FID (Shimadzu, Tokyo, Japan) described in Loftfield et al. (1997) for continuous CO₂, N₂O and CH₄ measurements and aerated at a constant rate (approx. 20 ml/min) for 155 day (22 weeks) at 20°C in the dark (figure 15).

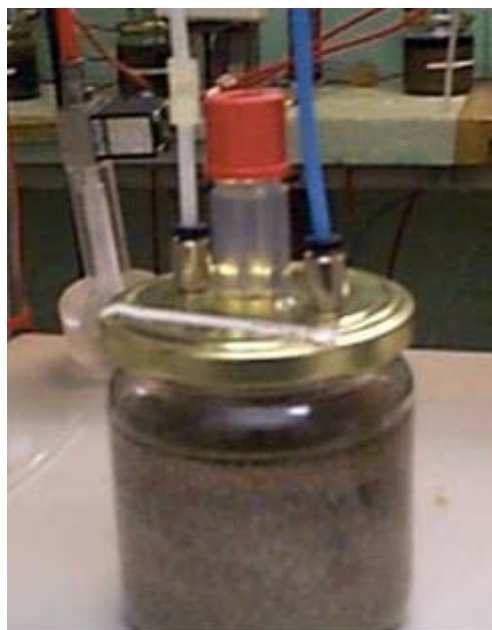
Figure 15. MC filled with sediment and water, and connected to the aeration and GC system

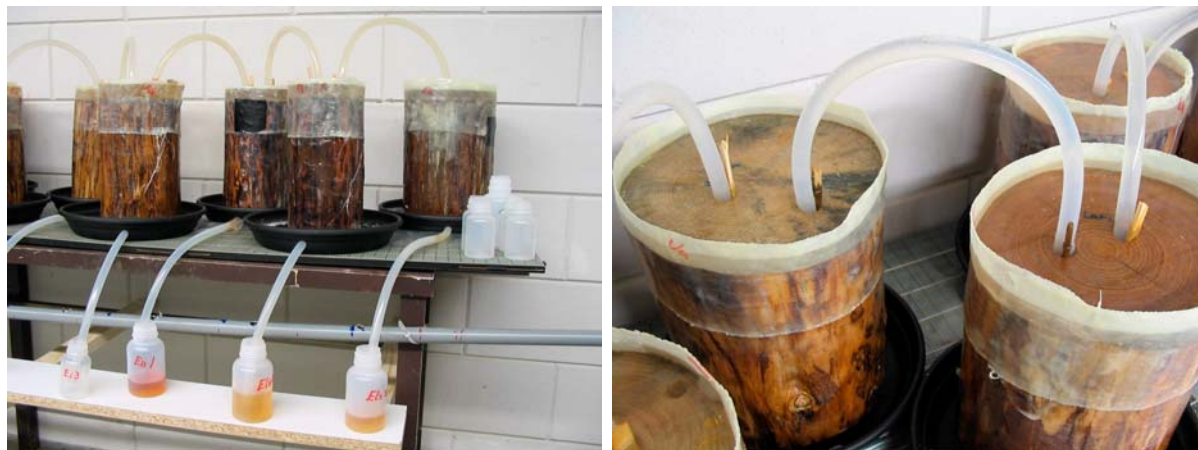
About 10 mm water was put upon the cross section of the stems. The stems were put on a shelf with small rills, and in order to avoid evaporation a thick plastic sheet closed the upper part of the shelf. A tube was connected to the lowest point of the shelf to collect the amount of water in a container. Every week the container was emptied and the amount of water was measured.

Figure 1. Test set-up.

In the fourth week of 2004 the experiment started by measuring weekly the amount of water which came out at the underside of the stems. Because the water on the cross surface became contaminated by bacterial slime and algae, it was refreshed weekly from the seventh week onwards.

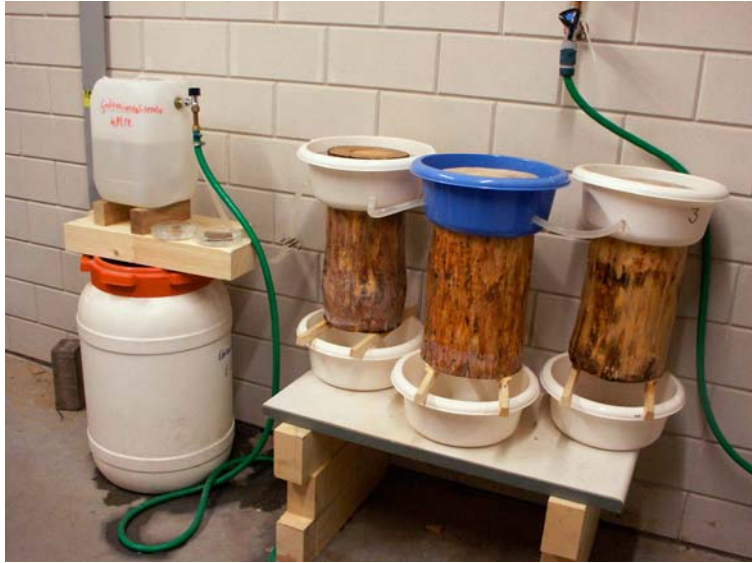
Three additional Scots pine (*Pinus sylvestris*) stems, supplied by Staatsbosbeheer (Ede) in October 2004 have been stored in water until sample preparation. The stems were debarked and sawn to a length of 400 mm. The outsides of the stems were coated with epoxy in a similar way as described for experiment 1. At 95 mm below the upper cross surface a collar of fibreglass was connected and impregnated with epoxy (see figure 2). In order to avoid a water stream through the cross surface the water level in the collar was 10 mm below the cross surface. The amount of water that came out at the underside of the stems was measured daily.

Figure 2. Test set-up experiment water flow trough bark.

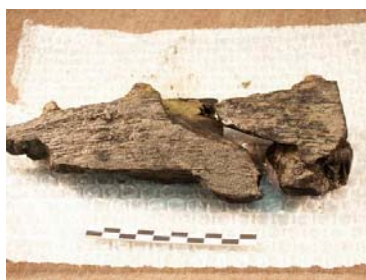
Figure 2. Fragment of wood with iron nails; iron sulfides - a lustrous gold color - have formed in a crack inside the wood.

The Fe^{2+} that is formed in this way reacts with the HS^- present (see reaction 5) to form an iron monosulphide (reaction 3). Part of the iron may also be formed by direct reduction with organic matter analogous with reaction (5) but this is not necessary. This monosulphide is usually relatively unstable. In most environments, it reacts with the elementary sulphur formed in equation (6) to form pyrite:

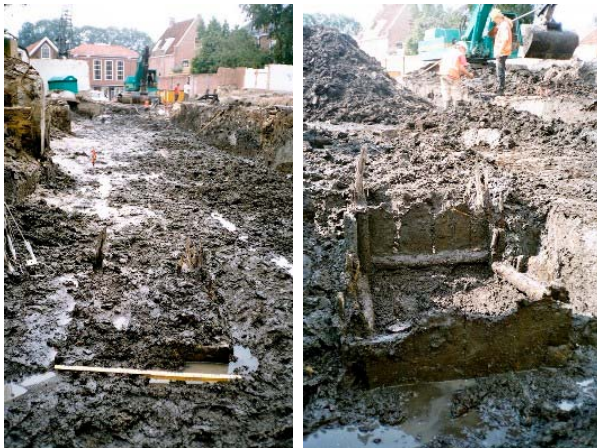
Figure 3. Left: the excavation pit with the outlines of the well (site 8) already showing in the foreground. Right: The square wooden structure is being uncovered.

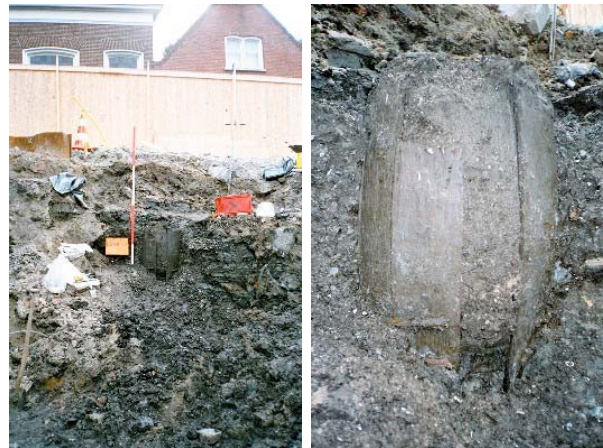
Figure 4. Left: The caved-in soil profile at the short end of the excavation pit (*Koningstraat*-side) and a newly discovered wooden object (site 9). Right: Close-up of the well-preserved barrel with discernible staves and hoops.

An oak barrel, uncovered in the short wall of the excavation pit near the street. It is probably older than site 8 and may have served some purpose in the backyards of the *Hoogstraat*-houses: “site 9” (see fig. 4).

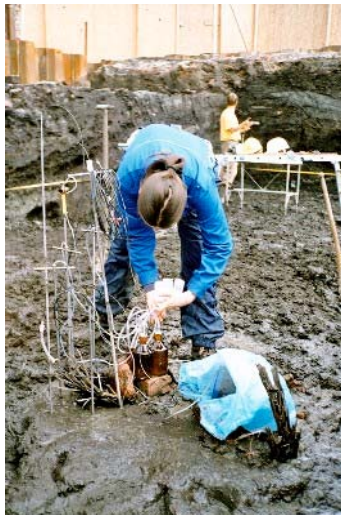
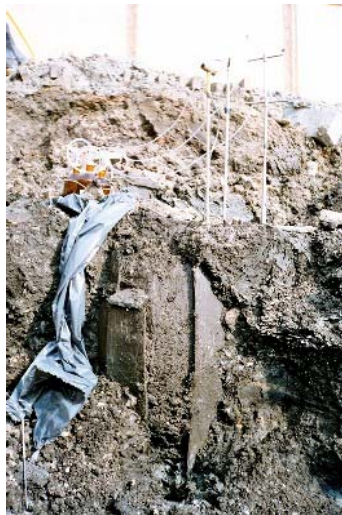
Figure 5. Measuring equipment is (being) installed on site 8 (left) and 9 (right).

Measuring equipment etc. was installed on site 9 (see fig. 5), on the outside of the barrel, close to stave 3, 12, 11 and 10 (see fig. 7), to be left overnight.

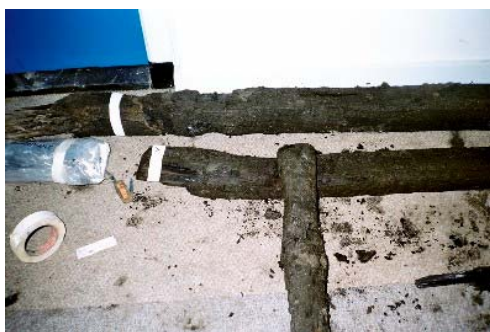
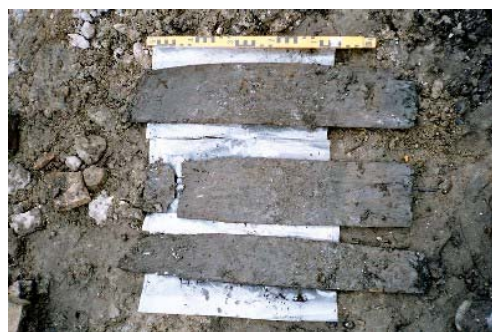
Figure 6. Sampled wood of site 8 (left) and 9 (right).

The barrel was emptied out completely, after several soil samples had been taken from within, and the remaining of its twelve staves were removed (see fig. 6). Three of the staves would remain with the ADC, because they showed special characteristics: the signature of its maker and a square hole for the plug or tap. Of the remaining nine staves four were taken directly to Göttingen. The other five were taken to SHR and RING together with the rest of the wood samples, in the switched-off electric cool box. The cool box remained very cold during the two-hour trip to Wageningen. Some of the samples appeared to have frozen when they were unpacked in Wageningen; it is to be hoped that this doesn't pose a problem for further research.

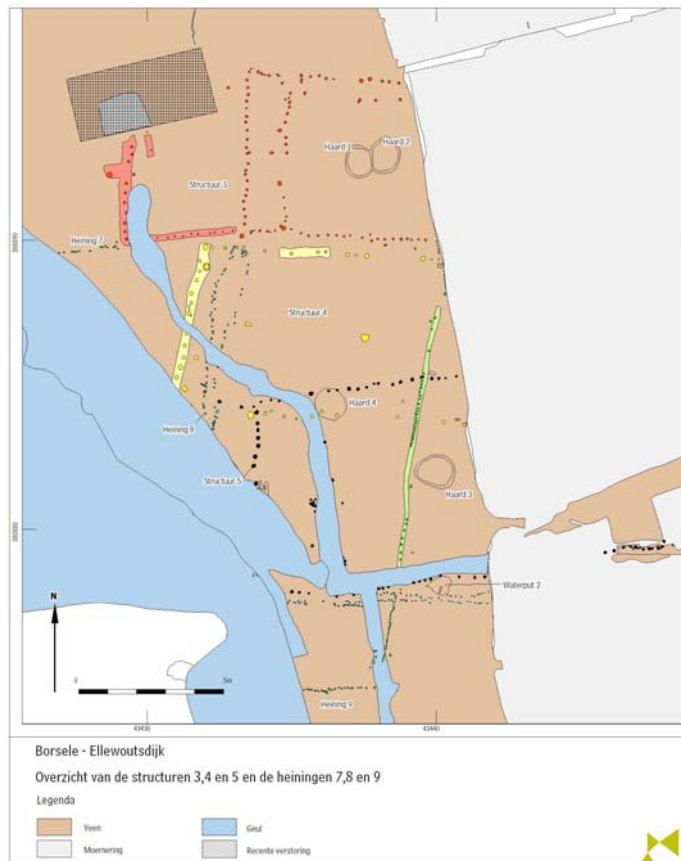
Figure 2. Overview of the excavated area showing structures, hearths and fences. (ADC)

When we started sampling for Bacpoles, the excavators were working on three house sites (figure 2) that had escaped damage by the dragline, because they happened to be located on one of the artificial islands. We were allowed to sample two central oak piles of an east-west orientated three-nave house (figure 3 and 4). These piles are supposed to have been the most solid construction elements of the house.

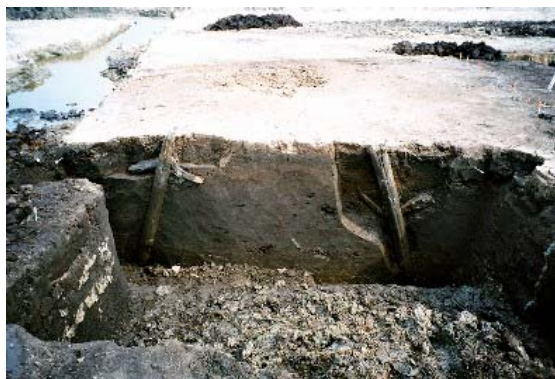
Figure 6. Features 112 (left) and 134 in profile.

Both piles are now completely visible in the profile of the pit: they are leaning very much towards each other (figure 6). It will be difficult to relate the position of the samples we take to the depth of the soil measurements. We decide to mark the best sample positions on the wood and then one of the archaeologists will indicate them on the drawing to scale of the profile.

The selection of the sample positions depends on special features of the poles: parts that are worked have to be studied by the wood specialist and cannot be sampled for Bacpoles. Both poles have pointed ends and close(r) to the top they have a hole with a wedge through it (figure 6), probably to keep them from sinking into the peat. Because the poles are so long (figure 7), there's plenty of sample material available, so we take four pieces of wood of 35 to 40 cm length. The diameter of the pieces is approximately 17 cm and they are almost perfectly round. Whole trees have been used for these poles; only the bark has been stripped of.

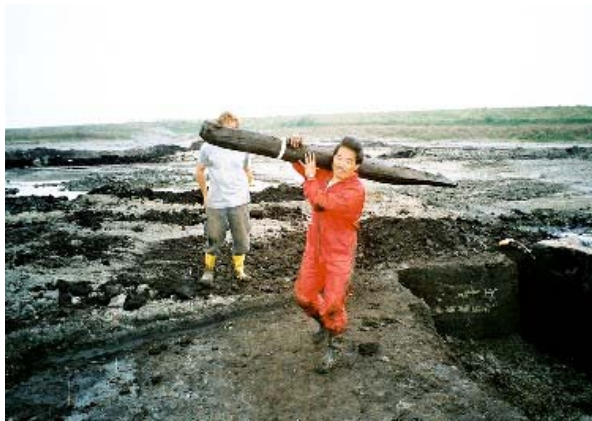
Figure 7. After documentation, pile 134 is removed from it's context.

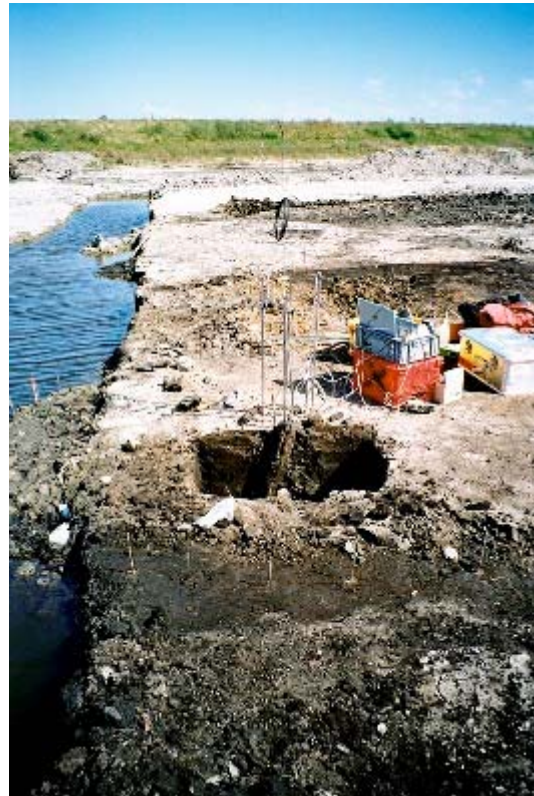
Figure 5. Sampling and measuring equipment is installed next to feature 112, one of the main piles of the house.

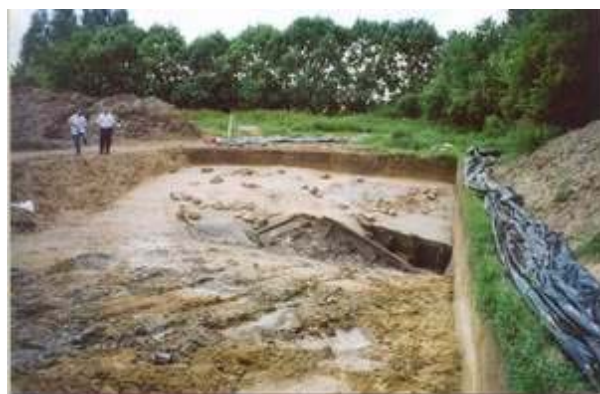
Figure 1 Overview of the excavation pit. Visible are basalt rocks of the shore reinforcement, the ship and the wooden embankment. The roman road is thought to lie directly behind the far face of the pit.

The general layout of the site is demonstrated in figure 1. Figure 2 gives a more detailed picture of the river embankment and the ship lying near it during the excavation. The plateau directly behind the embankment was used as a basis for the redox-measurements and the soil water sampling (figs 3 and 4). Choosing the exact positions for this on the plateau proved to be difficult; there appeared to be large amounts of wood present in the soil within 30 cm from the surface. Wood and stone were present around 80 cm depth.

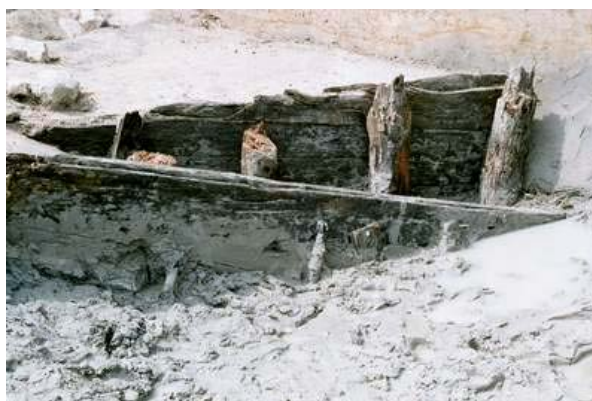
Figure 2 Detailed photograph, showing the embankment and the side of the ship. The two poles on the right are of oak, the other two are elm. The pole farthest on the right is sampled for BACPOLES (Sample V116).

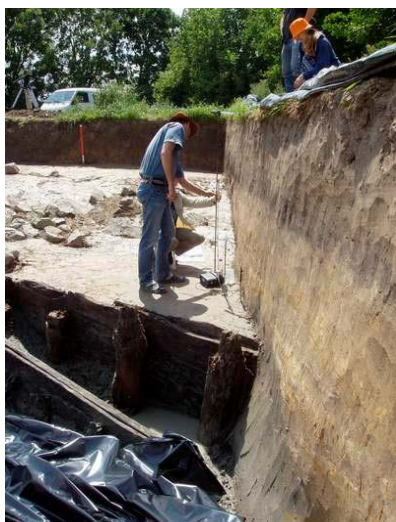
Figure 3 Positioning the measuring and sampling equipment on the plateau behind the embankment. The ship is in the foreground, partly covered in plastic.

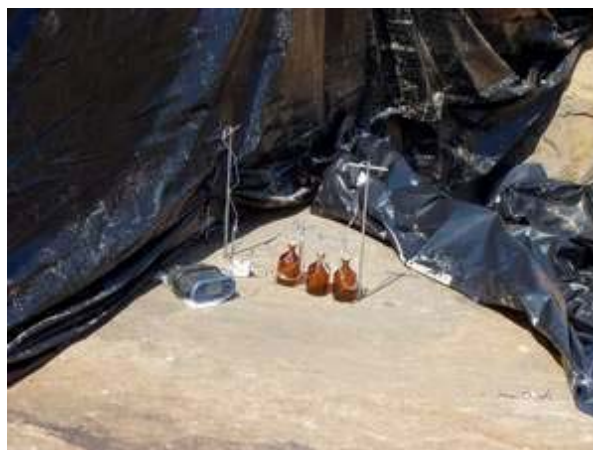
Figure 4 Impression of the sampling and measuring equipment when installed. The embankment and the ship are now completely covered in black plastic to protect them from damage by drying out.

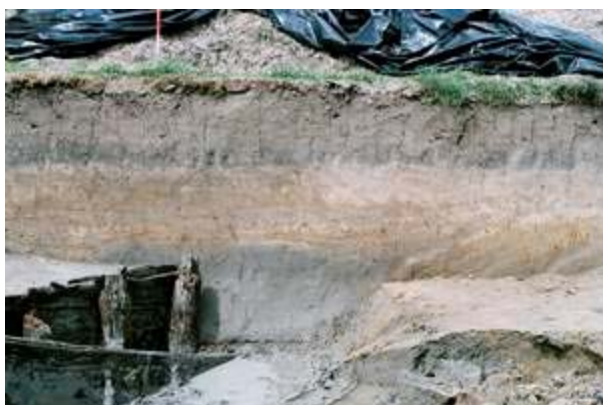
Figure 5 Side-view of embankment and side of the ship. The grey colouring in the facing wall indicates sediment that (until the time of excavation) was reduced, i.e. probably permanently below groundwater.

At the start of the excavation, groundwater level was estimated at or just below the top of the plateau. This can be seen from figure 5: the grey-blue section of the facing wall indicates that these sediments, prior to excavation, were reducing (i.e. dominated by Fe^{2+}). This is corroborated by the observation that nails and other iron parts of the ship were covered with a layer or concretion of siderite (FeCO_3), a typical product of reducing, Fe^{2+} -rich freshwater environments. In the sediment above this groundwater level, no wood survives; in figure 6, the part of the ship that was lying above groundwater had deteriorated to ground traces (discolorations in the soil). Here, nails are covered in rust or degraded to rust-coloured stains.

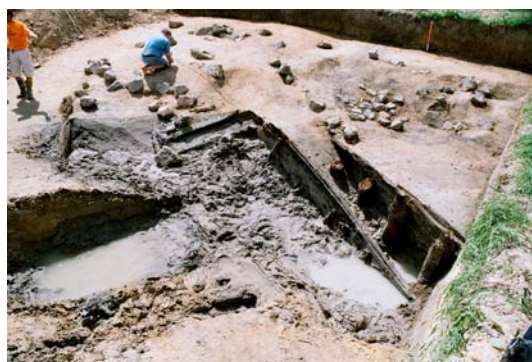
Figure 6 Overview of the ship and its position next to the embankment. The bow of the ship (top of the photo) has deteriorated because it was above groundwater for an extended period of time. It was visible only as ground traces, which were being accentuated by one of the archaeologists.

There was considerable variation in soil texture at the site, varying between fine sand and heavy clay. At the location of the redox-measurements and soil water extractions, texture was estimated to be fine sand to clayey sand. The area between the ship board and the embankment consisted of heavy clay, as did the infill of the ship adjacent to the embankment (see fig. 6). The rest of the ship lies in coarser sediment; fine sand to sandy clay.

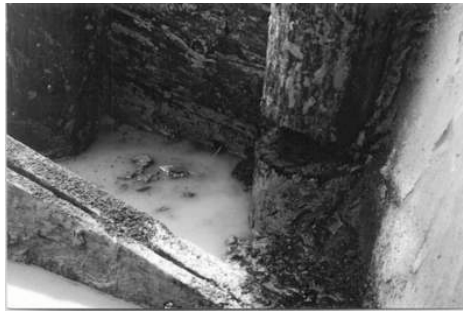
Figure 7 Oak pole of the embankment after the woodsample ("wedge") had been taken

As **wood sample** for BACPOLES, one wedge of wood was retrieved from one of the oak poles (V116; see figs 5, 6 and 7), from a depth of 58 cm below the standing level. For ROB-research on the wood quality of the ship and the embankment, a series of six oak samples. In order to compare deep and shallow parts of the wood, pairs of samples (one deep and one shallow) were taken from the embankment and from both sideboards of the ship (V108 - V113). An additional sample was taken from the top of the (elm) pile 3 (V115); this part was broken off during excavation. At RING, immediately a dendrochronological dating was done of samples V115 and V116: V115 appeared to date from the autumn of 99 AD, while V116 was from the spring (March /April) of 100 AD. Additional wood samples (oak planks) became available in 2004 when the plateau behind the embankment (where the measurements had been done) was excavated during a subsequent excavation.

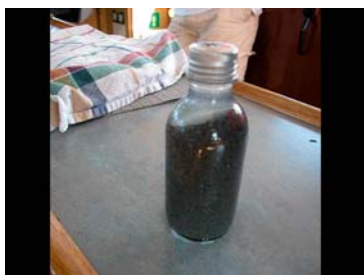
A 100 ml bottle filled with sediment from under the wood samples

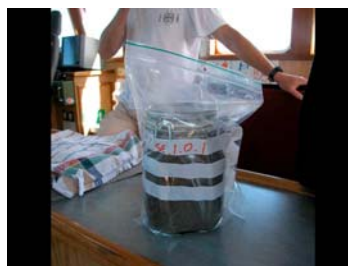
The bottles were also packed in plastic. This 1 litre pot is filled with sediment from the surface of the sea bottom. Sample 12.se.1.0.1

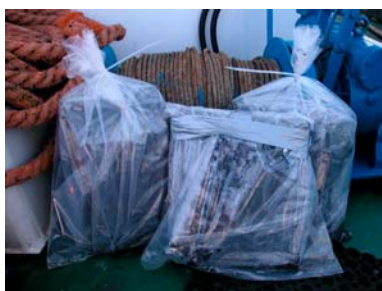
The wood samples, one oak and one pine shell planking, were packed in plastic on the sea bottom.

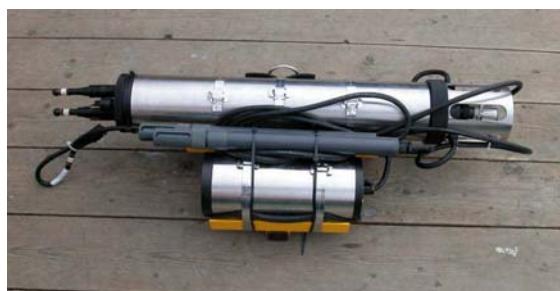
With the WaterWatch 2681 datalogger from EauxSys Ltd. data about the water and sediment conditions have been measured.

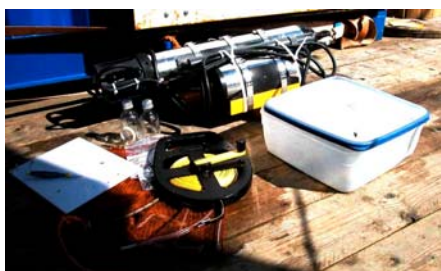
Overview of the equipment used to sample the wreck site: the datalogger, measuring equipment, 100 ml bottles for the water and sediment samples and boxes to transport the samples to the surface

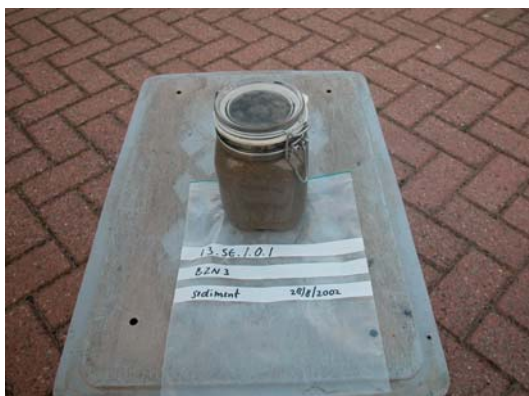
One liter sample of sediment from the bottom surface.

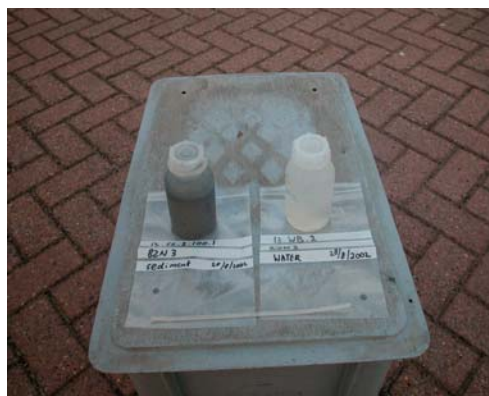
Water and sediment sample from the area around the woodsamples. They are packed in 200 ML plastic bottles.

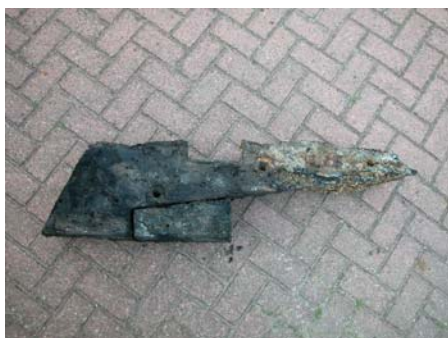
Part of the wale that was sampled for dendrochronological analyses (samples BZN 3-352 and -353)

The wood that is sampled is pine. Its function was probably to protect the oak shell planking against shipworm (*Teredo navalis*). The pinewood doubling of the shell planking was only found on one of the thicker wale. This is strange; usually the doubling of the shell against shipworm is only done under the water level. Wale are found above the water level. The conclusion of this is: or it was doubled higher up than usually done to prevent a ship from being eaten by this shipworm or the ship was doubled for another reason: for example to protect it against enemy gunfire.

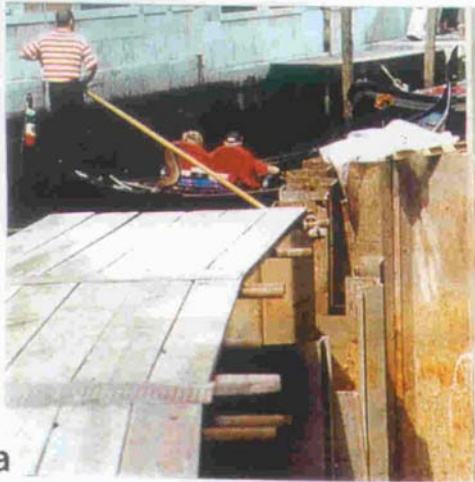
a

Penetration depth measured with Pilodyn, Type 6J
(diameter pen 5 mm)

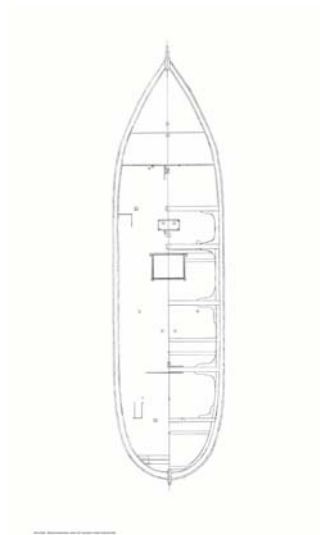
Fig 2. A reconstruction of the ship construction at the orlop-deck-level (Bohusläns museum 2003).

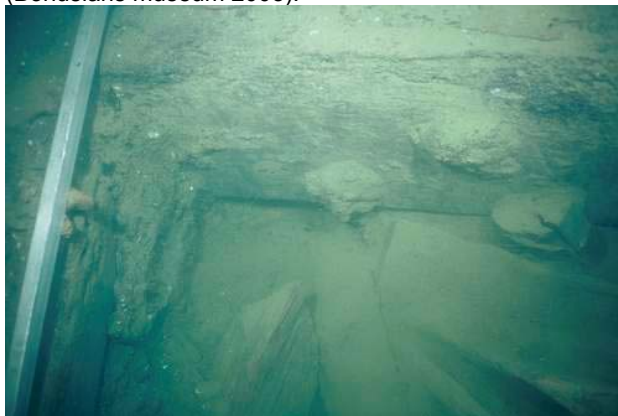
Fig 3. Trench 1. One of the massive deck-beams of the orlop-deck. A lot of firewood and a big oak-barrel were found in the trench (Bohusläns museum 2003).

Two years ago The County Museum of Bohuslän inspected the wreck and it became then obvious that the site was suffering from severe erosion. Water movements, artificial and natural, were in progress to erode the protective sediment layers and by that threaten the preservation of the wreck. In order to prevent the decay the museum started an *in situ*-preservation last summer (2002). The first part of the project included a documentation of the exposed remains of the wreck (fig 1-2). Two small trenches were dug to evaluate the density of the layers and to find out how much of the hull that is preserved and at what state (fig 3).

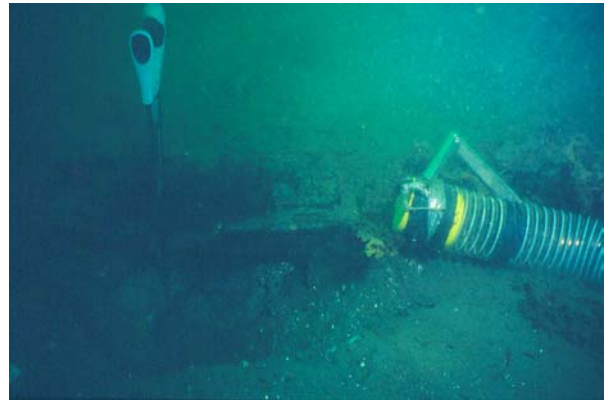
Figure 2. The NW test-pit during sampling from one of the planking. Photo: Staffan von Arbin/Bohuslän County Museum

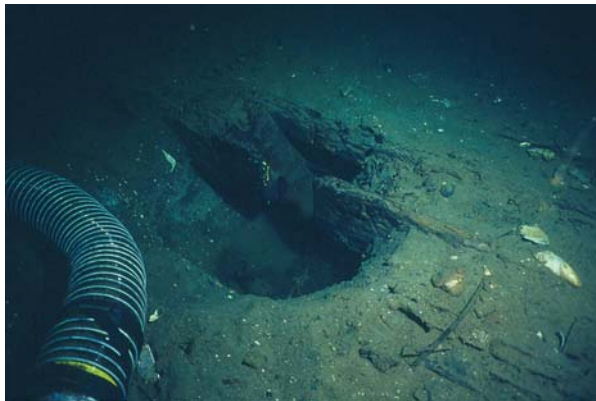
Figure 3. The SE test-pit after sampling from two of the planking. Photo: Staffan von Arbin/Bohuslän County Museum

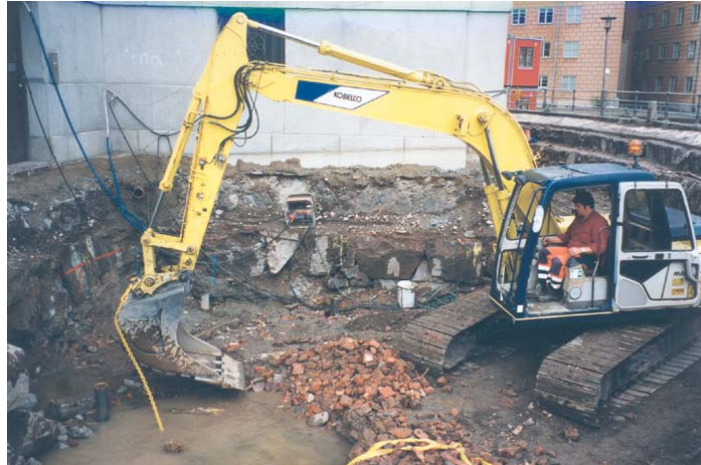
Close to the walls of the Parliament. Great forces are required when the 7 m long pole are pulled out of the ground.
