Preserving cultural heritage by preventing bacterial decay of wood in foundation piles and archaeological sites

Final report

EVK4-CT-2001-00043

Bacpoles

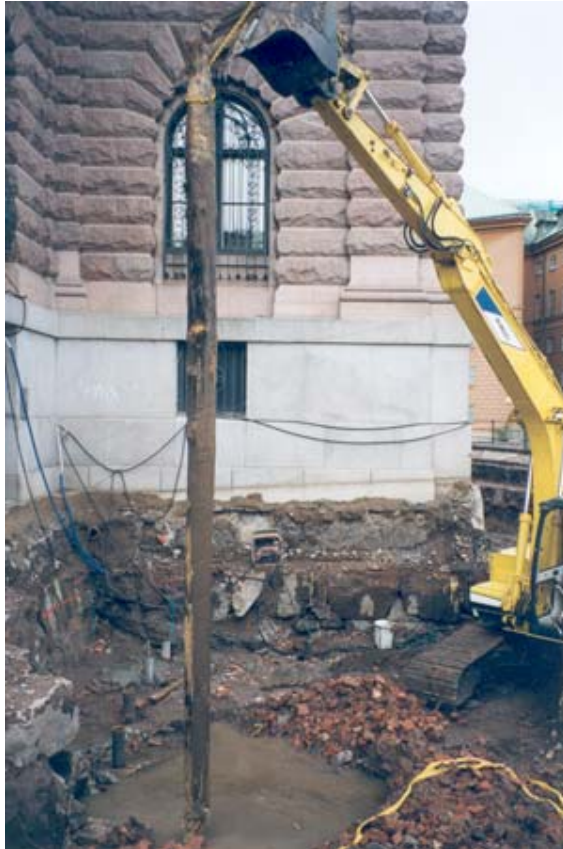
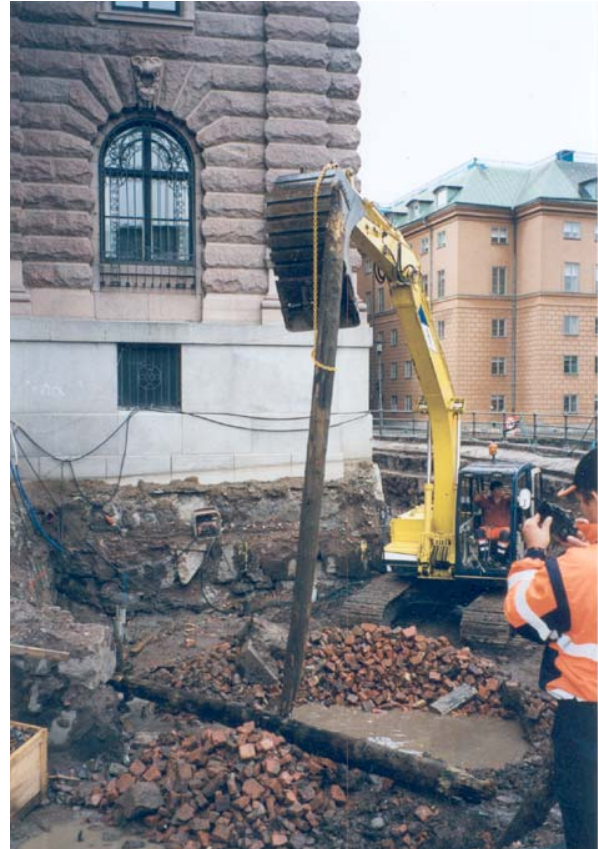
Two poles are pulled out the ground after 113 years of service.
Note the stone foundation and the old backfilling, -a blend of bricks.

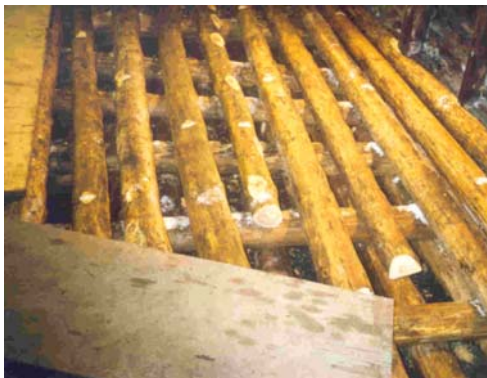
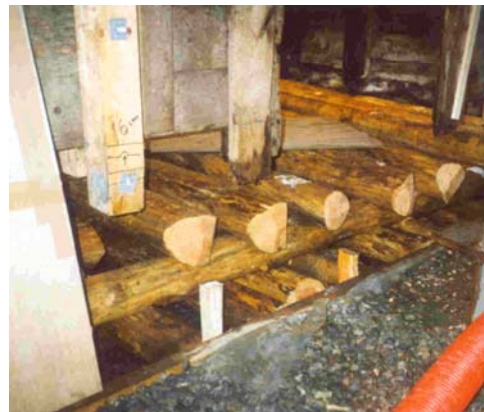
Pictures 2 and 3 reconstruction of the foundation in building Ve, in a traditional way with round wood Pine. The wood is covert salt crystal.

Bryggen is the remaining part of the old wooden harbour-area settlement in Bergen, Norway (see picture 1). The 61 standing buildings are approximately 300 years old, with pine-wood as the principal building material (in superstructures and foundations alike). The typical construction style is basically a kind of log-cabin technique with interlocking wall-planks forming the building's shell, and the foundations are usually made up of several courses of horizontal logs, either placed directly on the soil or sometimes supported by stones. The ends of the transverse foundation logs often project outside the buildings' side walls and extend a little way beneath the adjacent street surface (see picture 2 and 3).

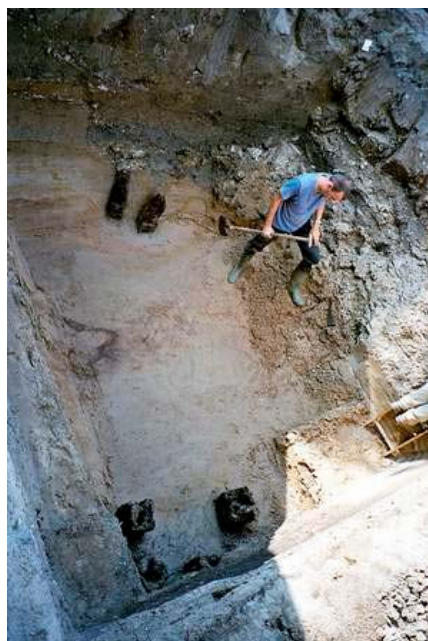
Figure 2. Overview of the excavation pit. Two piles can be seen at the west side of the pit (top of picture), four on the east side (bottom of picture). Of the latter, three were sampled for BACPOLES. Directly to the left of these piles, the small sandy plateau is the location of an oil tank.

In de pit under consideration, the archaeologists found the wall as expected; it was partly present as remains of the wall proper, partly as a ground trace where it was dug out in later times to re-use the stone. It appeared that a gap was present in the part of the foundation that was uncovered: Oak piles were present only close to the sides of the pit, in the middle no piles or traces of pies were present (see figs. 2 and 3).

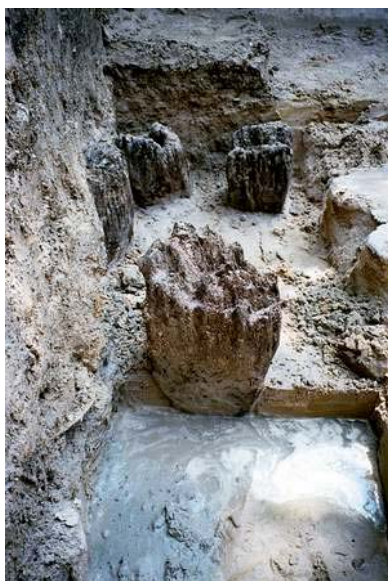
Figure 3 close-up of the largest pile sampled for BACPOLES (number SN 43; BACPOLES number 26.te.1). Soil samples were taken from the pit in the foreground, which clearly shows the ambient groundwater level relative to the piles.

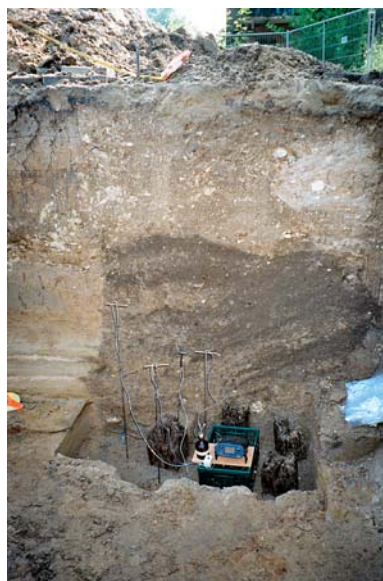
Fig. 4 Water extraction equipment and redox probe installed around the foundation piles. In the profile, the dark area is the pit that was dug top install the oil tank, which lies to the right of the piles (underneath the plastic bags).

For BACPOLES, we selected the first piles that were uncovered, i.e. at the East Side of the pit. Here, four piles were visible. It was decided to do the measurements and sampling around the largest and best accessible pile (known by the archaeologists as S43). This pile and two of the others (numbers S32 and S41) were taken as woodsamples (see fig. 4).

One disadvantage of this location that the piles were next to an abandoned oil tank that had been leaking. All piles in this area were more or less contaminated with oil. The oil tank probably dates from the first half of the 20th century, but it could be as late as the 1960's. It is unclear whether the contamination is as old as the tank. It could be seen that the top of the piles had been exposed when the oil tank was placed; they were completely surrounded by the debris-containing clay that was used to fill up the pit, with no original surrounding sand present (cf. colouring in fig. 4).

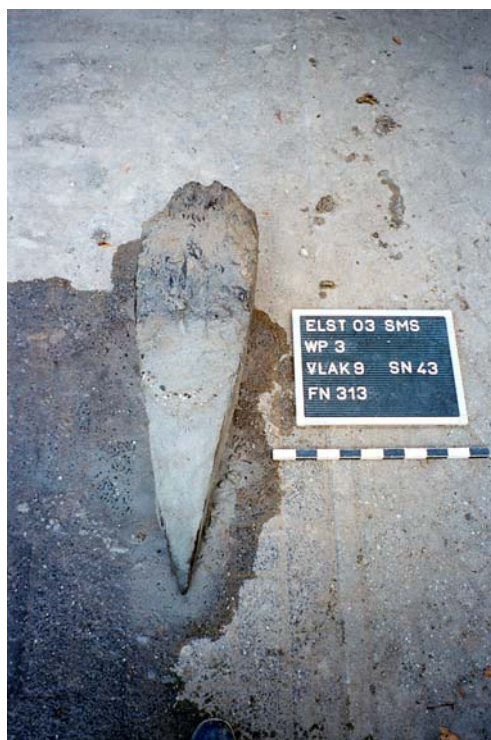
Figure 5. Largest pile (S43) taken as sample for BACPOLES. Still sticking to the pile is gravel from the coarse sediment in which it had been standing.

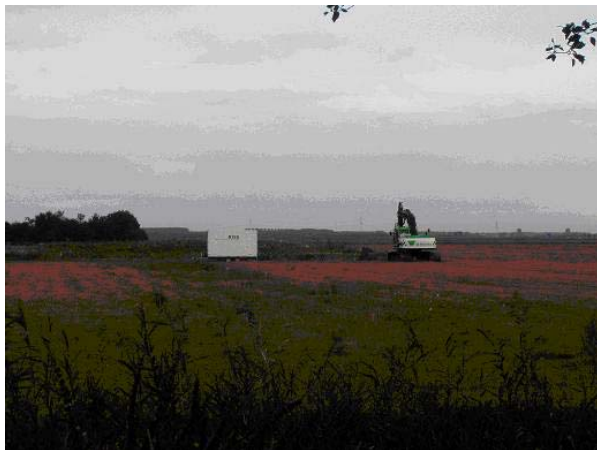
Figure 1: overview of the location site 27 (lot GZ80). The artificial mound that was made as a protective measure can be seen from the left of the digging machine towards the left edge of the photograph.

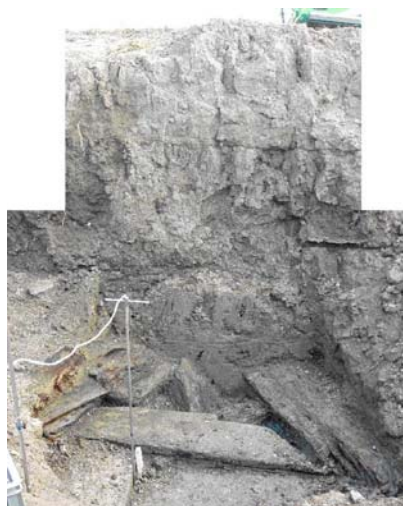
Figure 3: Soil profile in excavation pit of site 27 (lot GZ80), with the ship's wood lying at the bottom. The brown to blue-grey colour transition at the bottom of the profile represents the redox-boundary. The wood below this boundary seems to be in reasonably good condition, whereas the wood above it (to the left in the picture) is brown, crumbly and soft (instead of black and firm).

From these observations, the redox-boundary is estimated to lie around -6.59 meter depth.

Depth (related to NAP)	Description
-4.65 - -6.03	Building-sand; placed on top of the wreck after discovery as protection against drying out
-6.03 - -6.15	Calcareous sand; original plough-layer before discovery of the wreck
-6.15 - -6.45	Brown clay with rust-stains. Locally observed jarosite (and possibly gypsum) indicates that pyrite oxidation is active
-6.45 - -6.59	Horizontally layered brown clay with thin sandlayers. Some rust-stains
<-6.59	Blue-grey clay

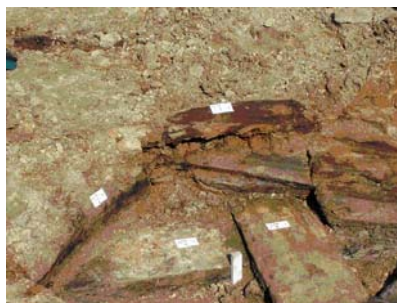
Figure 4: photograph of the site with wood samples 1 to 4 indicated. Wood sample 5 is underneath no. 2.

Four pieces of wood were selected for sampling. They were all oak planks, and lying horizontally (see fig. 4 and table 1). Sample 1 was in bad shape due to its presence in an oxidised soil layer. The underlying pieces become progressively better with increasing depth. Only sample 4 is (at least partially) embedded in the blue clay below the redox-boundary at - 6.59. The depths given are the depths of the top of the wood. After removal of sample 27.ta.2, a plank of probably pine was found immediately below, and recovered as sample 27.ta.5. It was very soft, as one of the lysimeters had been pushed through it by accident without anyone noticing.

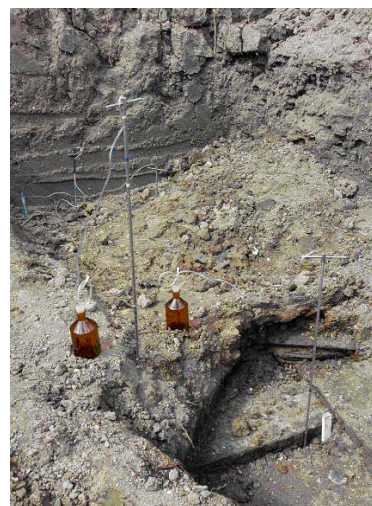
Figure 5: lysimeters and redox-probe installed in less-than-ideal locations. Lysimeter 3 and redox-probe are in the background

Placing the filters for pore water extraction - as well as the redox-probe - proved to be difficult as wood and ballast stones underlying the sediment made it almost impossible to find spots where the appropriate depths could be reached. As a result, 2 out of the three pore-water extractions were at less than ideal locations. Filter #1 was directly next to the beam samples as wood sample # 4, filter #2 was directly on top of the same beam (with a distance of 71 cm from #1. It later was found out that it had penetrated wood sample 5, and may have taken most of its moisture from that piece of wood. Filter #3 was farther away - some 1.5 meters - as was the redox-probe (see fig.5).

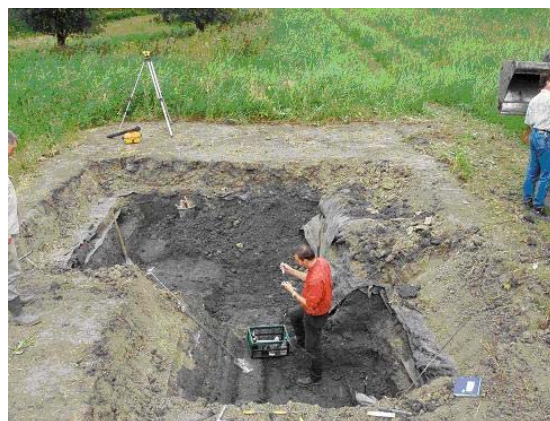
Figure 7. Sampling location and pit. Notice the plastic separating brown sand (on top) from dark-grey sand (underneath). The trees in the background are at the edge of a ditch that has dried out due to the dry weather.

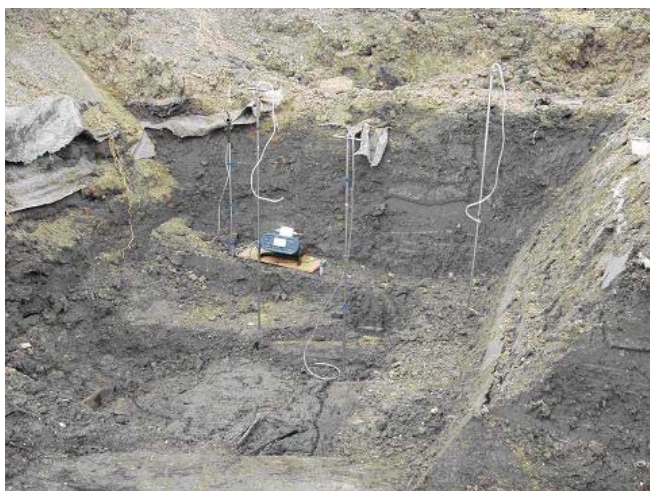
Figure 4: position of redox-probe and lysimeters (during setting-up).

We had problems similar to those on site 27 with placing the redox-probe and lysimeters; ballast stones and wood made it difficult to find a good spot. In the end, one lysimeter was put in the sloping side of the pit. The redox-probe was about a meter distant from the wood sampled (see fig. 3); the lysimeters were placed immediately around one wood sample # 1. Filter # 3 directly on top, filter #2 below and filter #1 at the same depth. The results of the redox-probe and the water sampling are in tables 2 and 3 respectively.

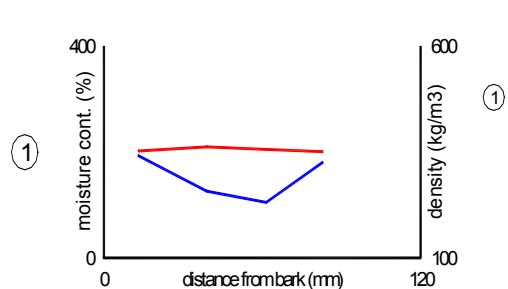
3.te.22(2)

3: Pile extraction Amsterdam, the Netherlands Pile 2, Height 2000 Pine
