Assessment of the quality and lifetime of wooden pile foundations

Paper prepared for the IRG48 Scientific Conference on Wood Protection
Ghent, Belgium
4-8 June 2017

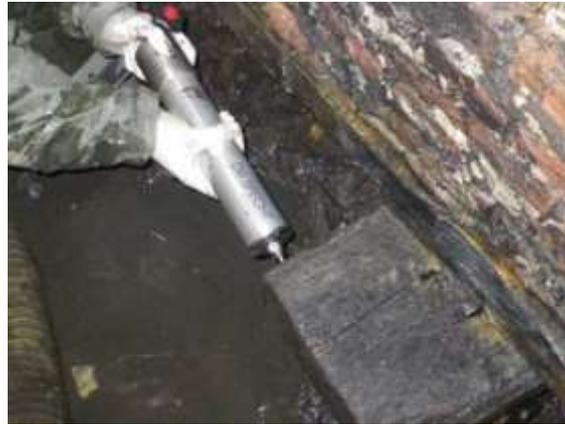
Figure 1. Test hamer

The method presented here, relies strongly on a test hammer. This is an apparatus that shoots a needle (5 mm in round diameter and 50 mm length) into the wood. The velocity of the needle is determined on 5,05 ($\pm 0,11$) m/s and the weight of the needle block is 460 (± 39) g. The execution of the measurements with the test hammer are easy and quick, also in a watery environment like a foundation pit. This enables the researcher to achieve several measurements of each of the wooden elements of the foundation construction (Fig. 1).

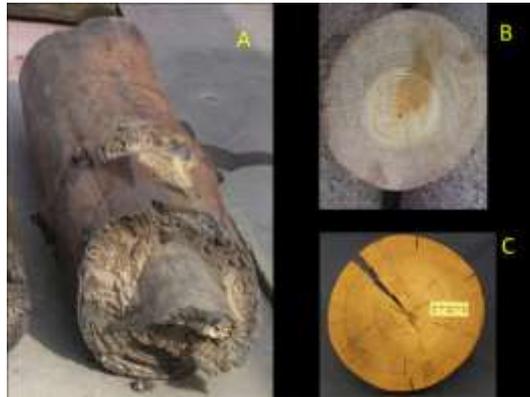
Figure 2. Three pile heads with a soft shell by bacteria decay, for each pile the app. diameter and thickness of the soft shell are given. A: wet broken pine pile head (14 cm / 5 cm); B: wet sawn cross surface pine pile head (18 cm / 6 cm); C: dry cross surface pine pile head (20 cm / 1,5 cm)

The test hammer is developed to indicated the thickness of the soft shell, which is the outermost layer of a wooden element that is severely degraded wood by bacteria (Fig 2). It is assumed that bacteria degrade wooden elements homogeneous from outside towards the inside.

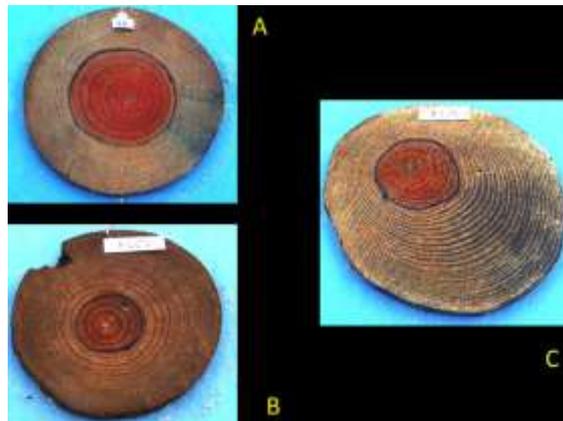
Figure 3. Example of variation in wood structure in pine pile heads of app. 16 cm in diameter. A and B show differences in sapwood width and C shows a asymmetric pith and compression wood at the right side

standard deviation and variance (ratio between the standard deviation and the mean values) are given. The mean values of the thickness of the weak shell ranges from 3 mm (sound or almost sound wood) until 35 mm. In 65% of all piles the variance is 20% or less, and in only 10% of all piles it is more than 40%. These data support the assumption that bacteria degrade the outer most layer in a homogeneous way. The variation found, depends on the structure of the stem, especially in stems with an asymmetric pith. Reaction wood (with other strength properties than regular growth wood) as well as the sapwood width (the area which is sensitive for bacterial decay) will cause differences in the thickness of the weak shell (see Fig. 3).

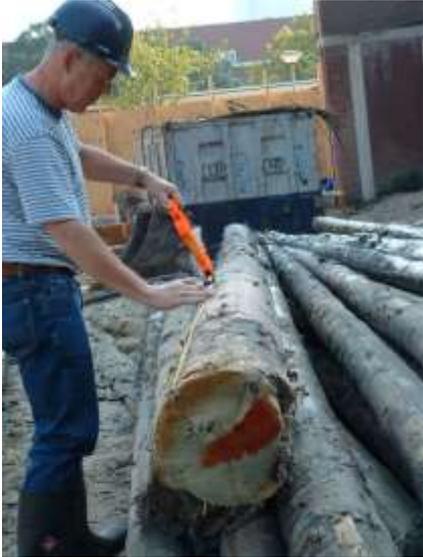
Figure 4. Extracted piles to be inspected and measured over their full length

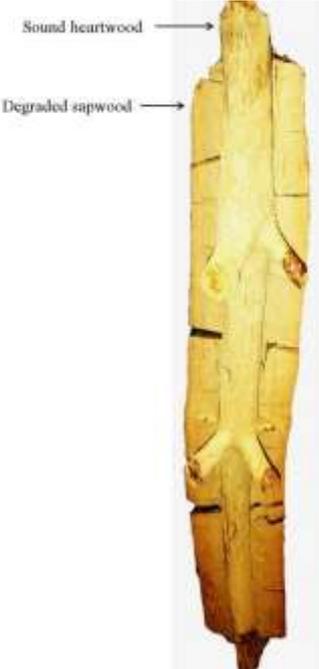
Figure 5. Example of the impact of bacterial decay on a pile (original diameter 130 mm, after 75 years in service and decay, the sound diameter was 35 mm only)

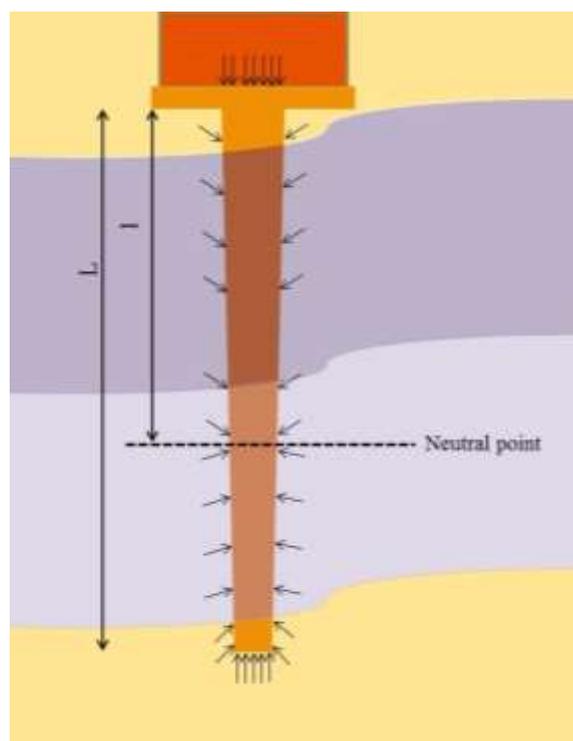
Figure 7. Location of the neutral point in a timber pile in service (sand layers are yellow, weak layers purple, orientation of the load on the pile is given by arrows)

The load bearing capacity of the timber pile should be calculated at that point over the pile length where the load is at maximum. The length of wooden foundation piles is adapted to the depth of the stable sand layer. The constitution of the weak soil penetrated by the piles consist of a variety of peat and or clay layers each with their own weakness and stability. The compression of the weak soil layers and increasing sand fill (in order to adjust the street level) , creates an extra load at the upper pile part, the so-called negative skin friction load. At the lower part of the pile the soil layers contribute to the bearing capacity, the so-called positive skin fraction. On the bases of the sounding graphic the position in the pile can be determined where the negative skin friction changes towards a positive skin fraction. This is the position in pile with the highest load, the so- called neutral point (see Fig. 7).

At the neutral point the sound pile diameter is calculated using Eq. 3 that take in to account the taper value and the gradient of bacterial decay over the pile length.

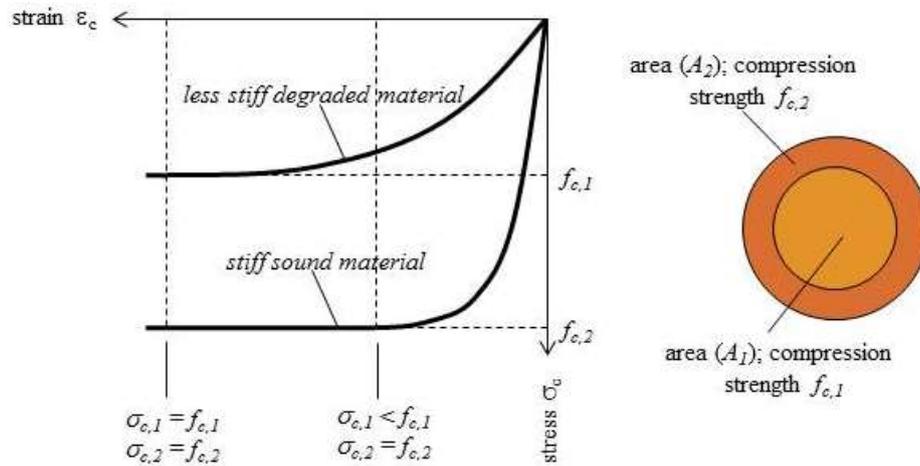
Figure 8. Effect of ductile behaviour (wood loaded in compression)

In the method for the determination of the design load carrying capacity in compression of the timber pile as described above, zero contribution of degraded part of the pile cross section is assumed. Therefore an alternative method could be used which takes a certain load carrying capacity of the degraded part into account. Since the timber response loaded in compression is ductile the reduced strength of the less stiff degraded part also contributes to the load carrying

capacity as indicate in Fig. 8. In the case of Fig. 8, assuming a uniform sound part and a uniformly degraded part, the design load carrying capacity can, assuming that a strain of ε_g is reached, be calculated according to Eq. 5.

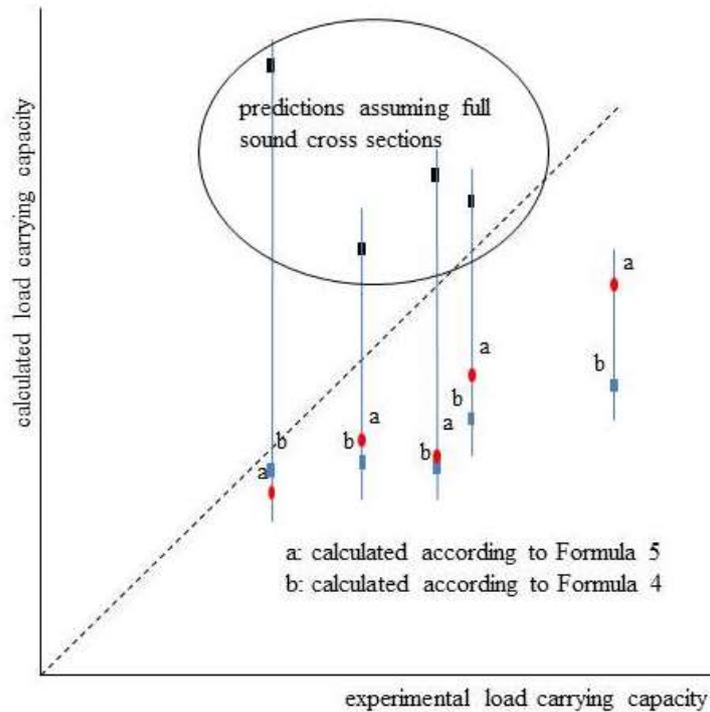
Figure 9. Differences in in load carrying capacity, using Eq. 4 and Eq. 5.

As an example, Lantinga (2015) calculated the predicted load carrying capacity according to both Eq. 4 and 5 for extracted piles, which were in service for more than 100 years, the results are (qualitative) shown in Fig. 9.

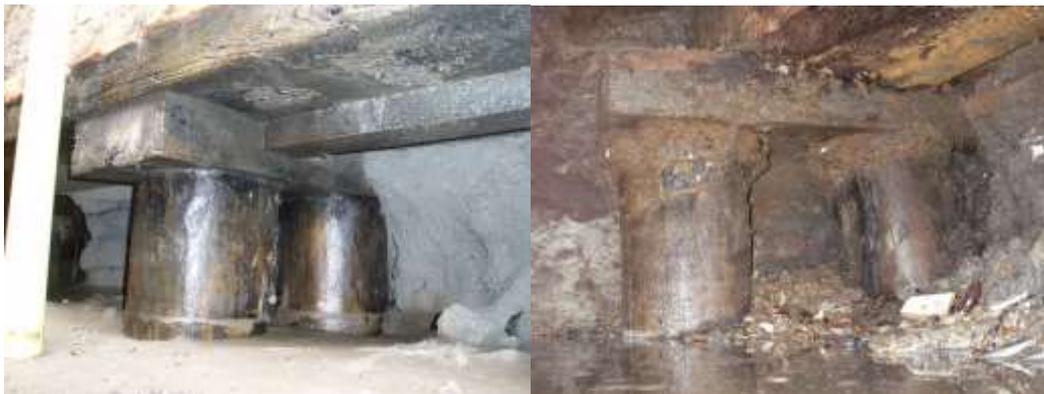
Figure 10. Two examples of common Dutch foundation constructions: two piles connected by a beam, covert by horizontal planks on which the bricks are situated. Both planks and beams are loaded perpendicular to the grain.

At the upper part of the foundation construction the pile load is transferred to the horizontal timber elements as shown in Fig. 10.
